Subject: The Goodyear Tire & Rubber Company - Pasadena, Texas
TNRCC Solid Waste Registration No. 30316
EPA ID No. TXD074185141
Interim Status Hazardous Waste Unit - Aeration Pond Closure File
LAW Project 50521-6-8800

**THIRD QUARTER GROUNDWATER MONITORING REPORT &
SUMMARY of ANNUAL MONITORING**

Subject: **Response to the Technical Notice of Deficiency for Closure Certification**
(Boiler M-526/Vessel V-411)
The Goodyear Tire & Rubber Company
Bayport Chemical Plant
Pasadena, Texas
LAW Project 60160-0-7301.2

**REVISED REPORT OF
RCRA HAZARDOUS WASTE MANAGEMENT
UNIT CLOSURE**

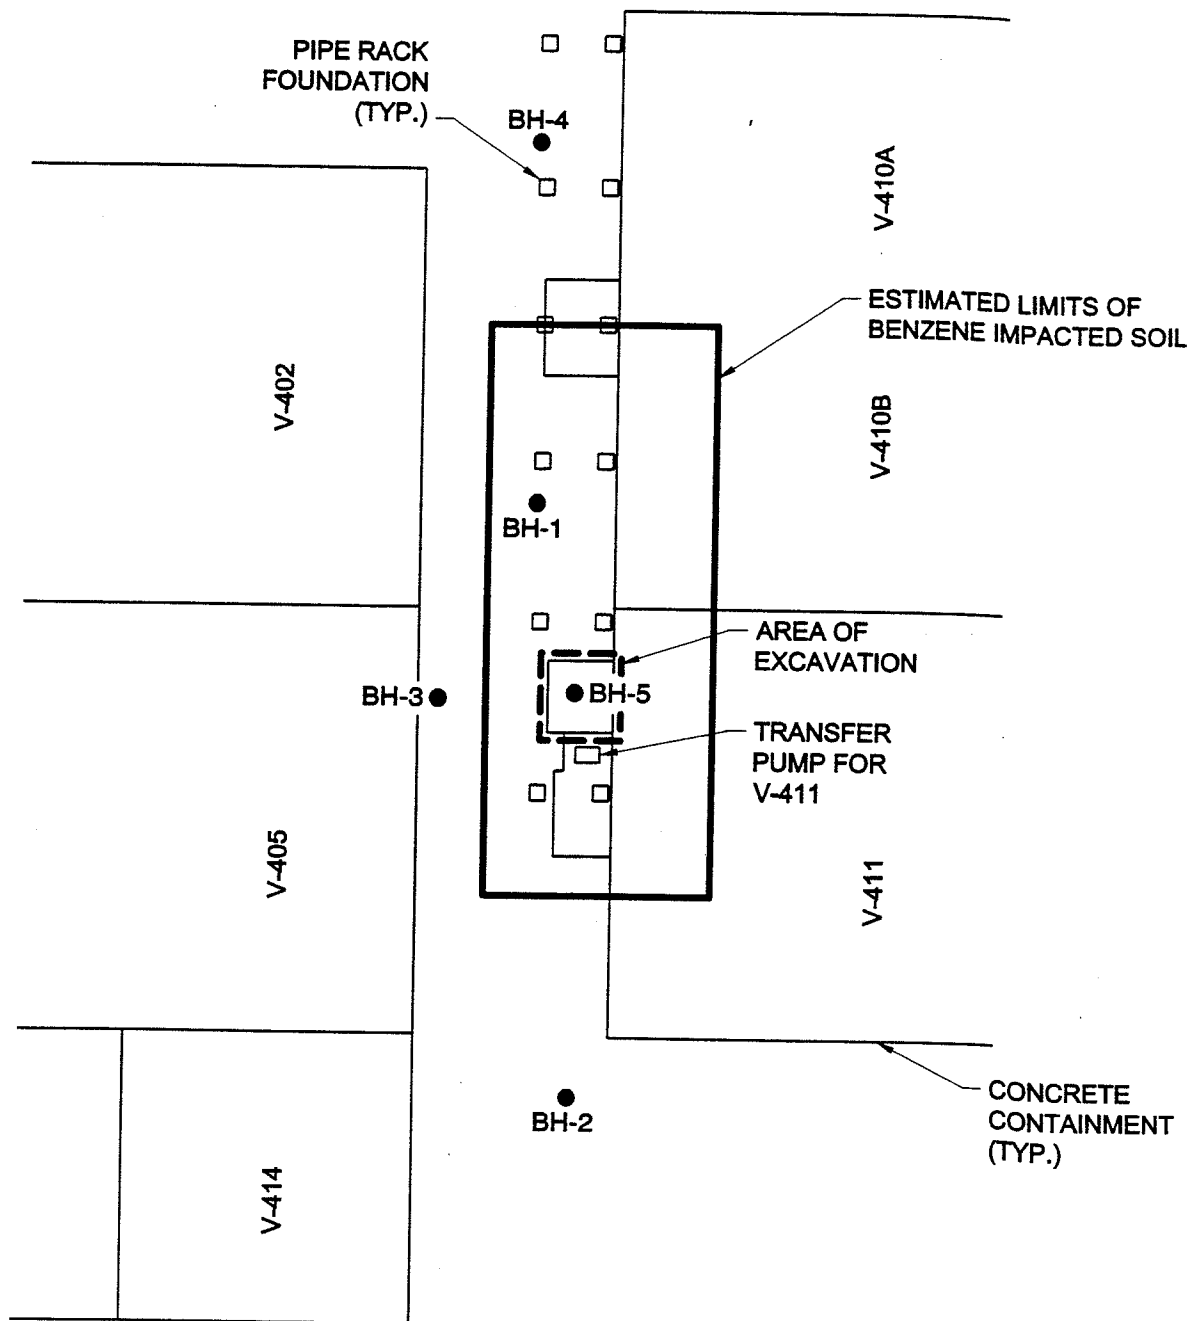
FIGURE 3

During the review of the original version of this report, issued in September 2000, Mr. Stephen K. Akers, of the TNRCC, questioned the validity of composite sample TP-2 in his Technical Notice of Deficiency for Closure Certification (Boiler M-526/Vessel V-411), dated November 27, 2000. On January 10, 2001 five soil borings (BH-1 through BH-5) were installed using direct-push methodology in and around the excavated area. Soil borings BH-1 through BH-4 were installed around the excavated area and are discussed in Section 2.6 of this report. Soil boring BH-5 was located in the previously excavated area to verify the laboratory results for sample TP-2 and help determine the vertical extent of impact. The locations of soil borings BH-1 through BH-5 are shown in Figure 3.

To determine the extent of contamination left in place soil borings (borings BH-1, BH-2, and BH-3) were installed to the north, west, and south of the excavated area using direct-push methodology (Figure 3). Delineation to the east of the excavation was not possible due to the presence of the concrete containment structure for Vessel V-411. The locations of the approximately 10 foot deep borings are shown on Figure 3. The descriptions of the soil types encountered in the borings are shown on the soil boring logs, presented in Appendix E of this report.
